# Manhole Inspection Summary

Manhole # S35QQ\_007MH

Insp Date: **1/22/07 8:49 AM**

**Location** Address: **2517 25 1/2 ST**

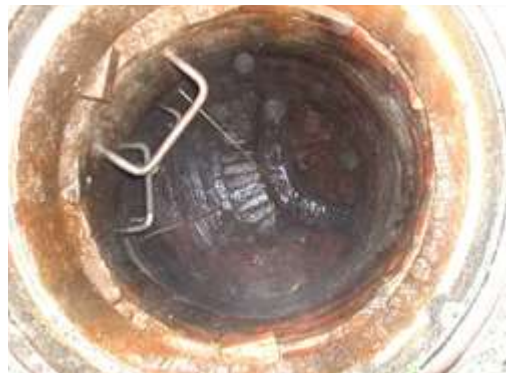
Top View

Bench debris.

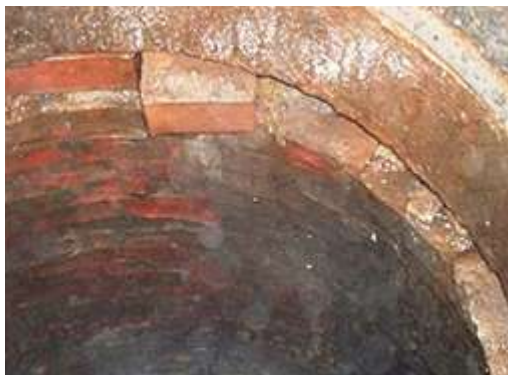
Defect

**Frame** Offset: **0** (in.) Condition: ☐ Sound ☐ Cracked ☒ **Leaks**

Condition: ☐ Sound ☐ Cracked ☐ Root Intrusion ☒ **Loose Brick** ☒ **Deteriorated**

Infiltration: ☐ None ☒ **Joint** ☐ Cracks ☐ Mortar ☐ Roots ☒ **Wall**

Frame leaks. Adjustment deterioration, loose brick and infiltration.
